Aug 5th, 2026

# Home Inspection Report

Seth Murray / Cornerstone Home Inspections

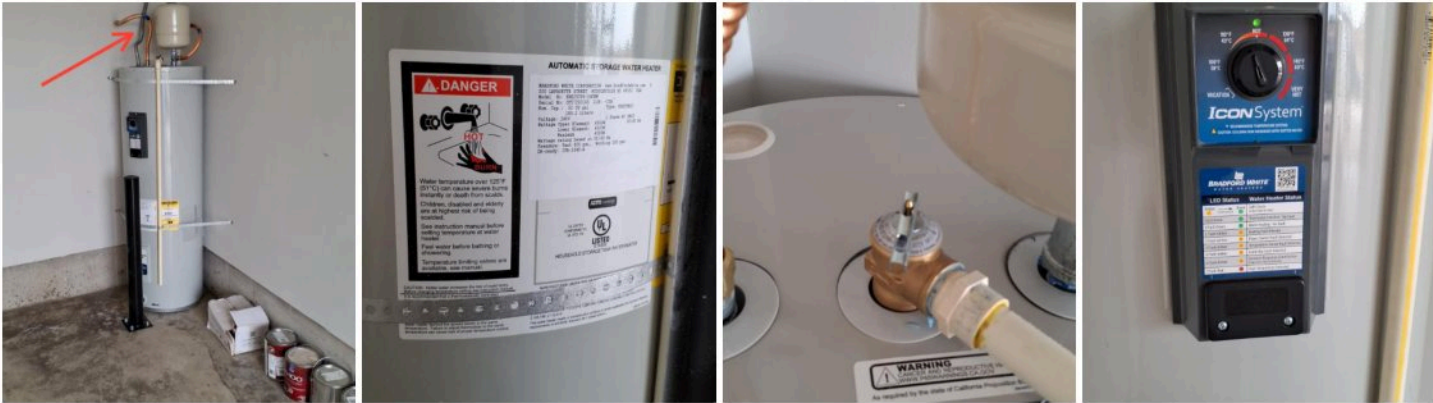
Could add insulation and a shutoff valve here.

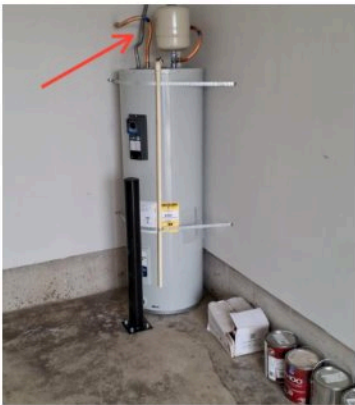
No water shutoff at water heater

A water shutoff valve on the intake (cold water) side of the heater is very helpful in the event of a water heater failure, leak, or maintenance.

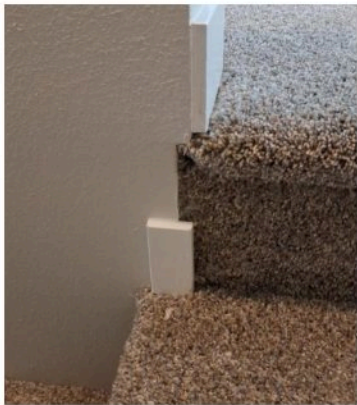
Minor, cosmetic trim issue.

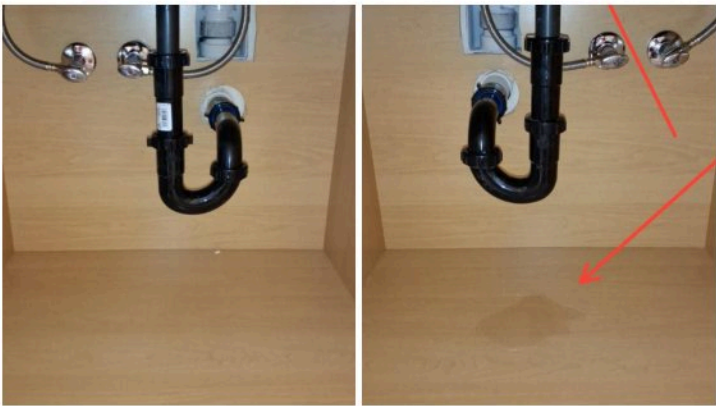
Leak at sink tailpiece.

Leak at sink tailpiece

Water is leaking around tailpiece of right sink.

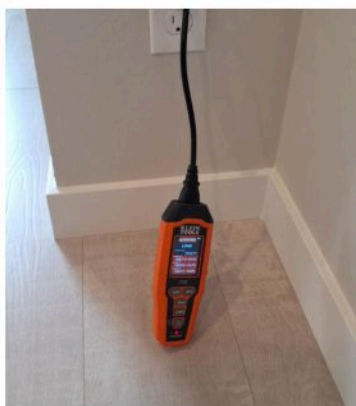
Over 5% voltage drop at 12A on multiple receptacle in living area.

Excessive Voltage Drop

Many receptacles on 15A circuits showed a voltage drop greater than 5% at a 12A load. This is common in older homes, but was unexpected in new construction. Evaluation by an electrician is recommended.

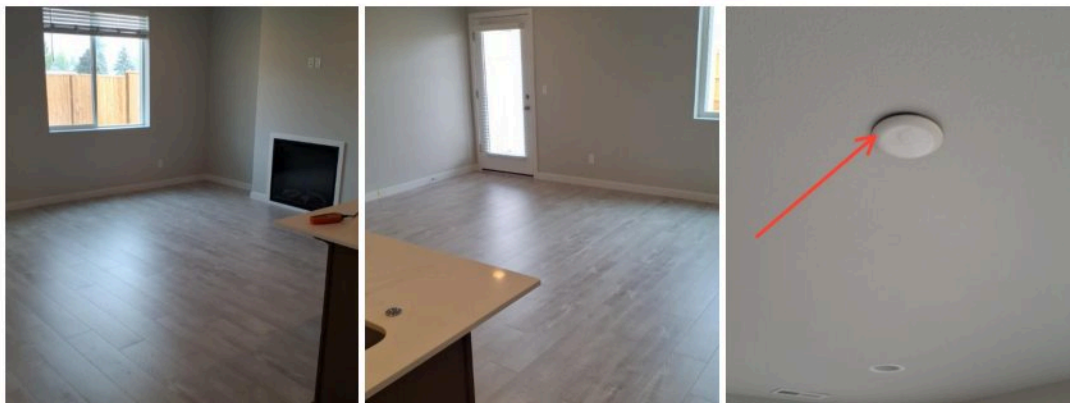
Mis-fitted electrical cover.

Electrical box cover in living room is not correctly seated. Might indicate mis-installed box beneath it.

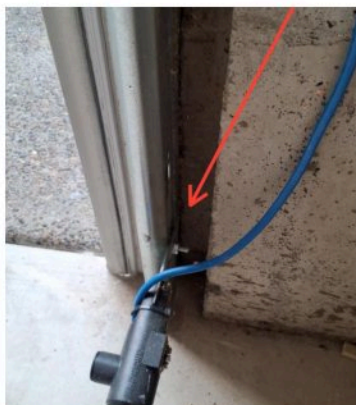
Garage door rails are not firmly mounted to wall.

The lower portions of the garage-door vertical tracks were not adequately secured to the supporting jambs and were loose or inadequately restrained. Garage-door tracks must be securely mounted and installed in accordance with the door manufacturer's installation instructions. Movement or spreading of the tracks may cause the door to bind or allow the rollers to become displaced, creating a potential safety hazard. Have the builder's qualified garage-door installer evaluate the complete door assembly and

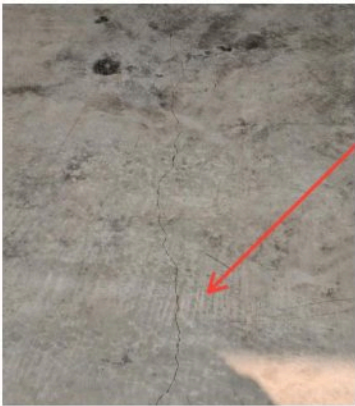
minor cracking in slab

Minor floor crack(s)

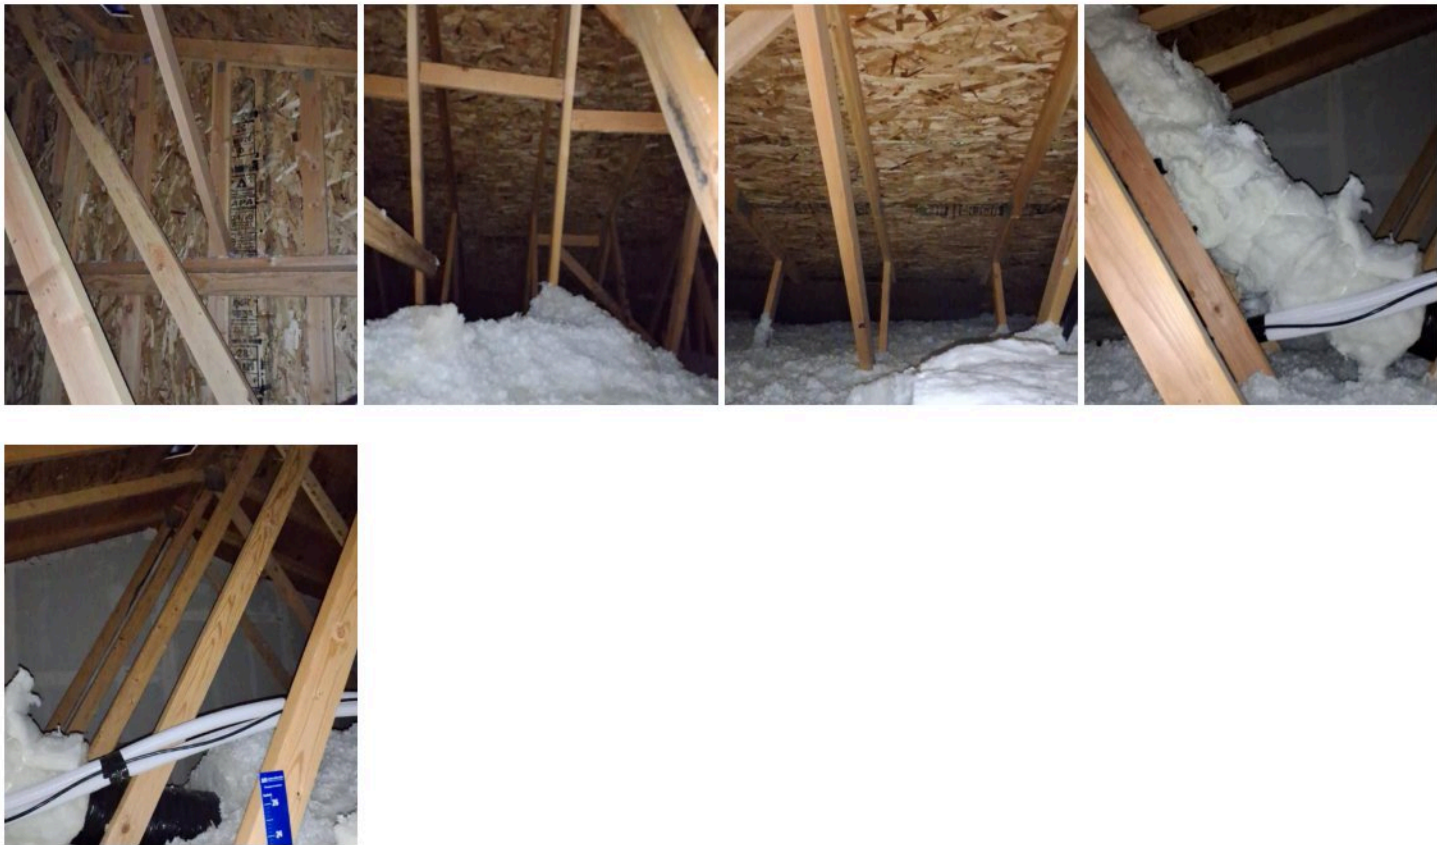
Ducting/Insulation block visual inspection of some components

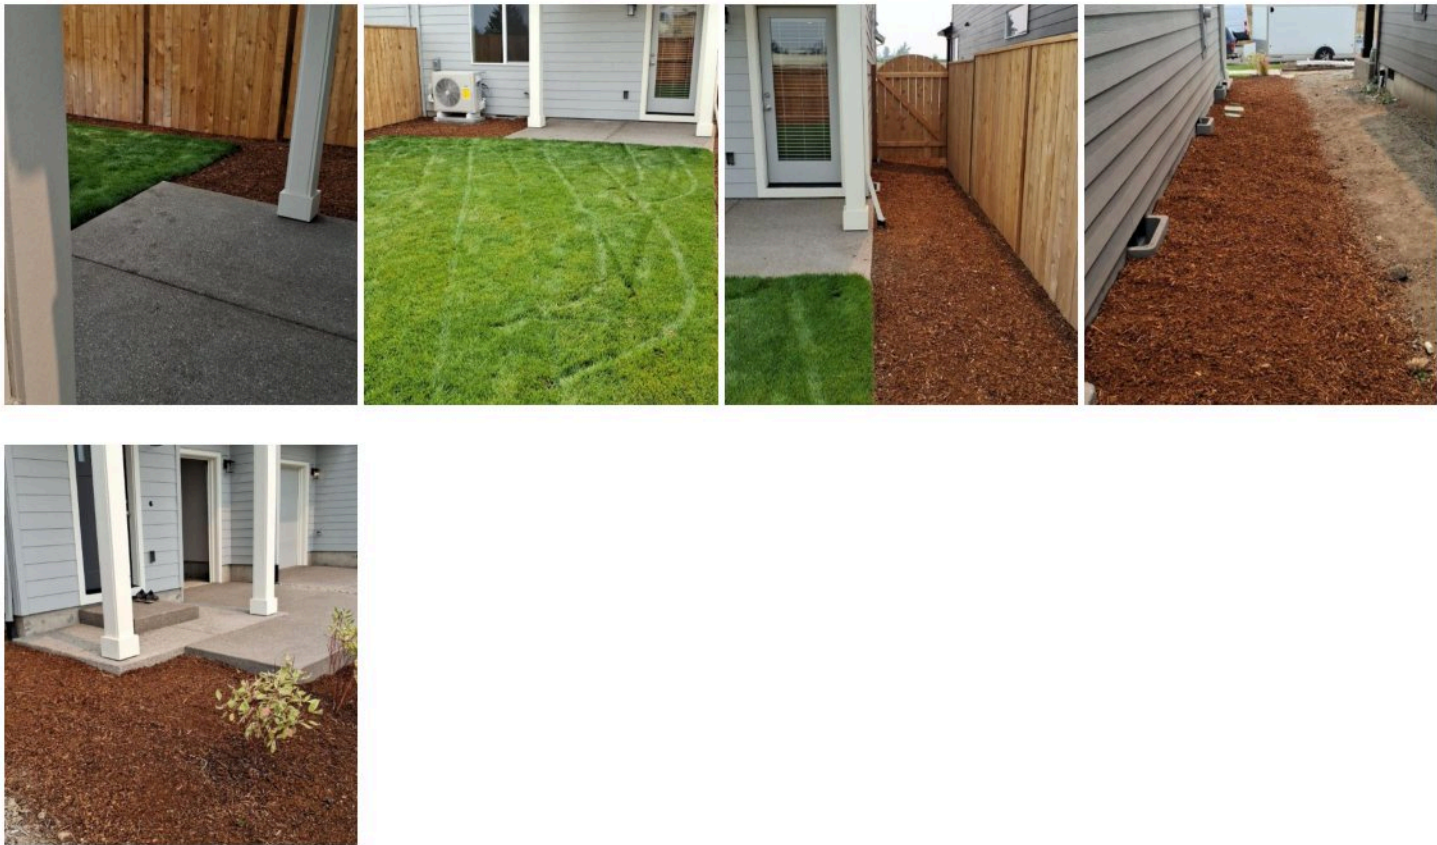
Ongoing observation recommended

Both the back yard and side access grades are such that they may become soggy during the rainy season. This could lead to moisture under the house or other problems. Recommend ongoing observation. If soil moisture becomes an issue, a French drain or similar can be installed.

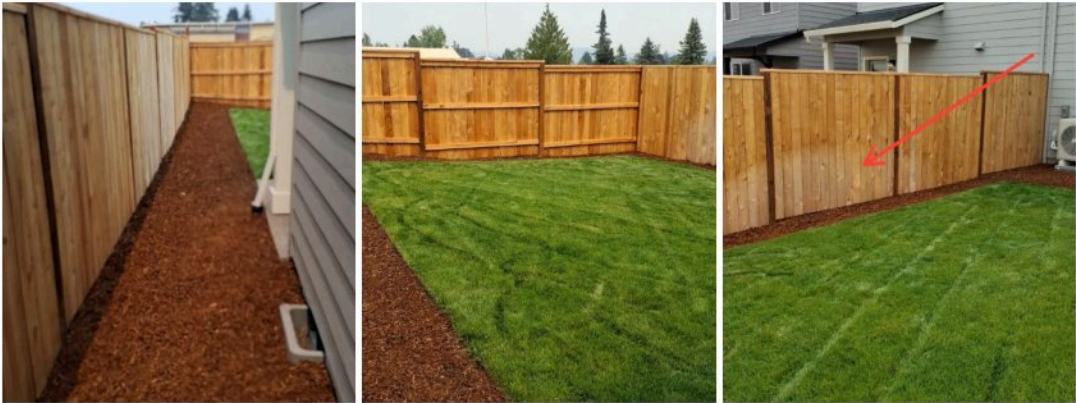
Probably a sprinkler hitting here. May want to adjust sprinkler.

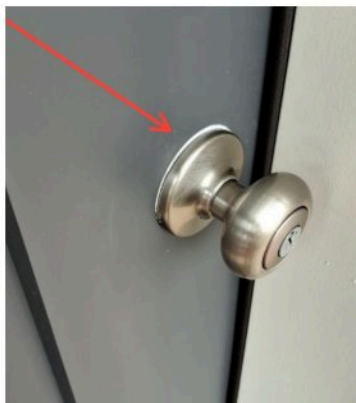
Just needs a little paint touch up.

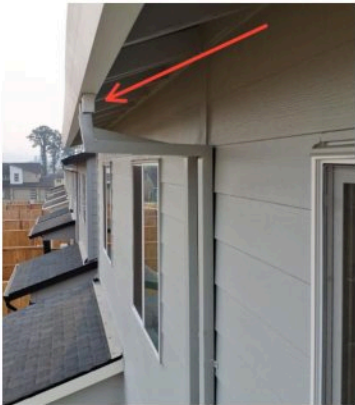
Downspout Separation

Downspout has separated from gutter, which will allow excessive rainwater to be in contact with (and eventually damage) siding. It will also collect at the corner of the foundation and may cause moisture problems under the home, or unusual/uneven ground settling leading to foundation/structural damage.

Recommendation: Have a contractor reconnect the downspout.

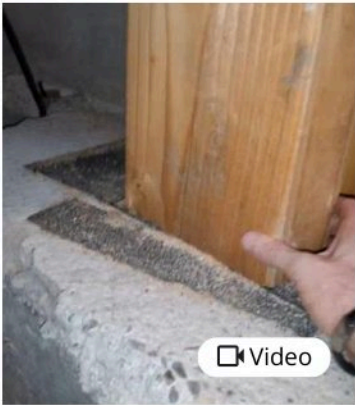
Supporting post is loose.

Loose/unseated support post

Recommendation: Monitoring

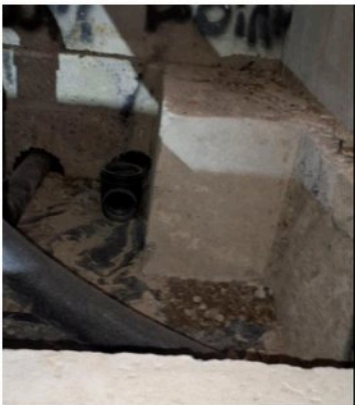
According to standard practice, vapor barrier should be continuous over all exposed earth, and extend up the insides of the perimeter foundation by at least 12 inches.  
Recommendation: Correction.
