# Summary

## HOME INSPECTION REPORT

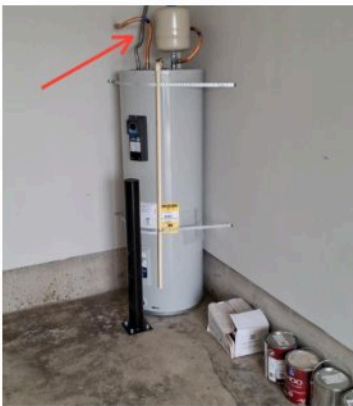
Insulation on exposed water lines

Adding insulation to the copper flex lines might provide some additional energy efficiency.

Upgrade Recommended

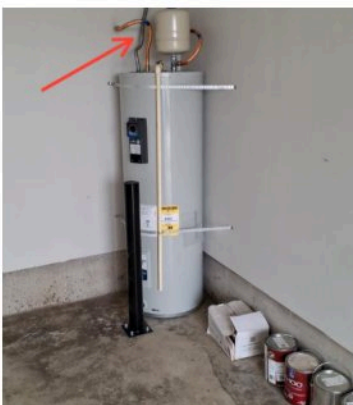
No water shutoff at water heater

A water shutoff valve on the intake (cold water) side of the heater is very helpful in the event of a water heater failure, leak, or maintenance.

Minor Defect

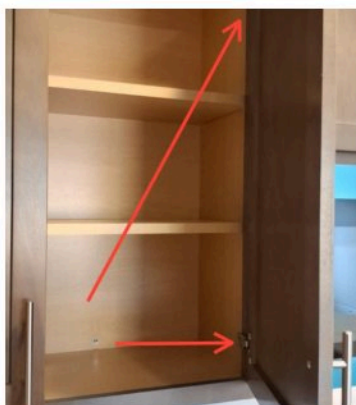
Binding hinges

Hinges on cabinet door to left of microwave seem to be binding.

Minor Defect

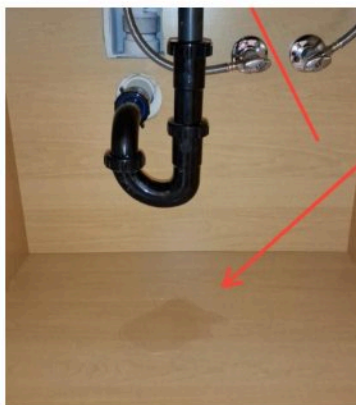
Leak at sink tailpiece

Water is leaking around tailpiece of right sink.

Minor Defect

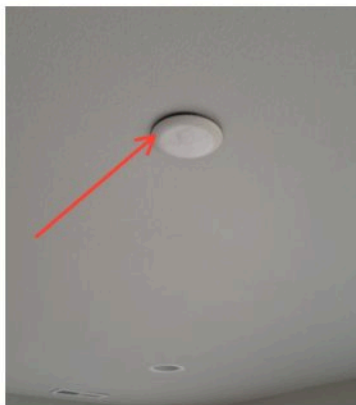
#### Electrical Box Cover Misalignment

Electrical box cover in living room is not correctly seated. Might indicate mis-installed box beneath it.

Minor Defect

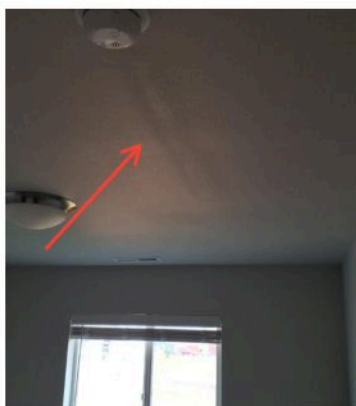
Cosmetic finish on ceiling

Evaluation Recommended

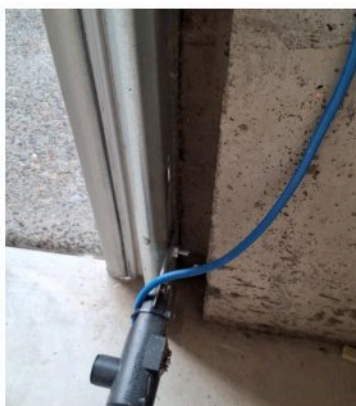
Bottom of door tracks not anchored. Have evaluated.

The lower portions of the garage-door vertical tracks were not adequately secured to the supporting jambs and were loose or inadequately restrained. Garage-door tracks must be securely mounted and installed in accordance with the door manufacturer's installation instructions. Movement or spreading of the tracks may cause the door to

bind or allow the rollers to become displaced, creating a potential safety hazard. Have the builder's qualified garage-door installer evaluate the complete door assembly and properly secure and adjust the tracks before closing. Do not operate the door until the installation has been evaluated and corrected.

Major Defect

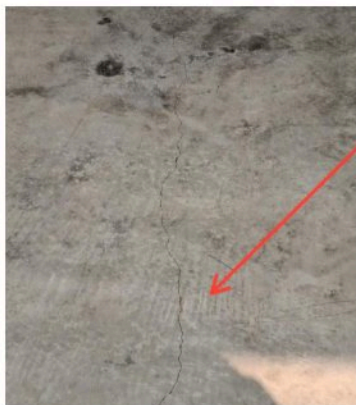
Minor floor crack(s)

Minor Defect

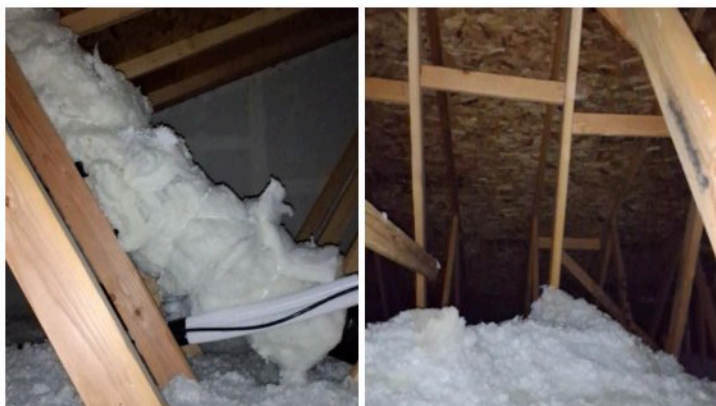
Ducting/Insulation block visual inspection of some components

Not Accessible

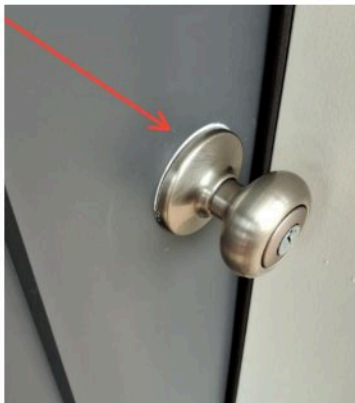
Minor cosmetic issue

Just needs a little paint touch up.

Minor Defect

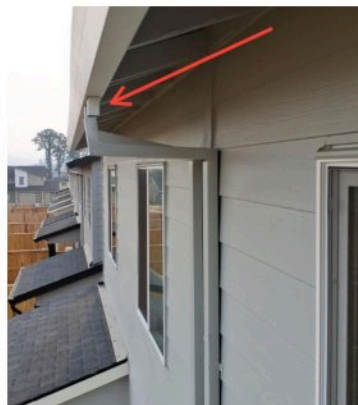
Downspout Separation

Downspout separation

Downspout has separated from gutter, which will allow excessive rainwater to be in contact with (and eventually damage) siding. It will also collect at the corner of the foundation and may cause moisture problems under the home, or unusual/uneven ground settling leading to foundation/structural damage.

Minor Defect

Recommendation: Have a contractor reconnect the downspout.

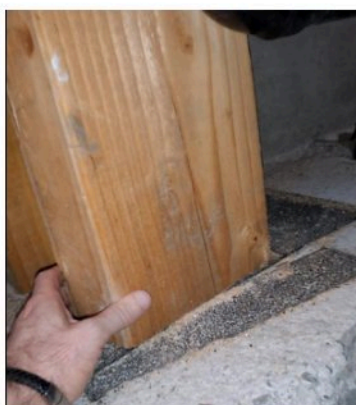
Loose/unseated support post

One of the support posts reachable near the crawlspace entry could be moved by hand where it meets the underlying concrete pier, indicating that it is not actually bearing load. It will likely naturally settle with time, but is being reported in the interest of being thorough.

Evaluation Recommended

Recommendation: Monitoring

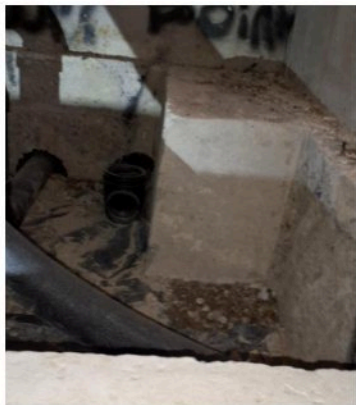
Insufficient vapor barrier

According to standard practice, vapor barrier should be continuous over all exposed earth, and extend up the insides of the perimeter foundation by at least 12 inches.

Minor Defect

Recommendation: Correction.
