Aug 5th, 2026

# Home Inspection Report

Seth Murray / Cornerstone Home Inspections

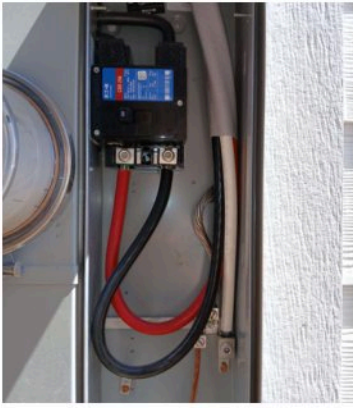
Main disconnect interior showing neutral-ground bonding

The grounding electrode conductor was observed at the service equipment; however, the grounding electrode and concealed/buried conductor termination were not visible for inspection. No visible defect was observed in the accessible portion of the grounding system.

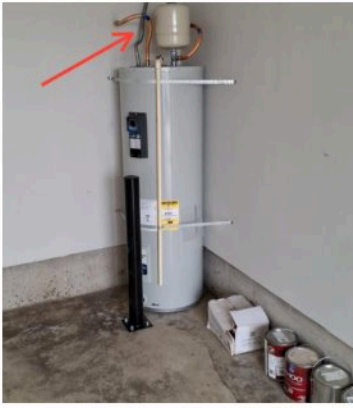
A water shutoff valve on the intake (cold water) side of the heater is very helpful in the event of a water heater failure, leak, or maintenance.

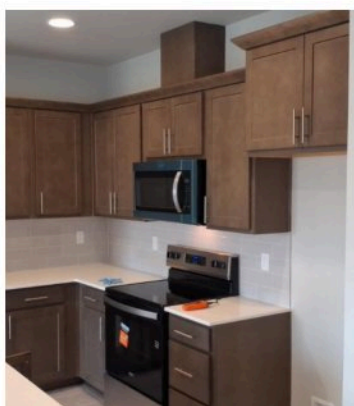
Binding hinge on cabinet door to left of microwave.

Binding hinges

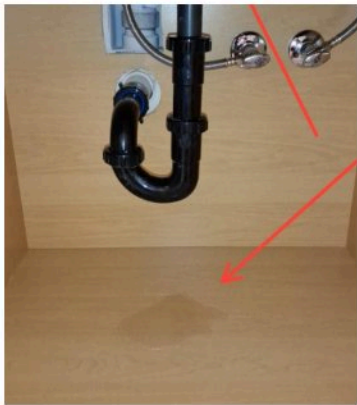
Leak at sink tailpiece

Water is leaking around tailpiece of right sink.

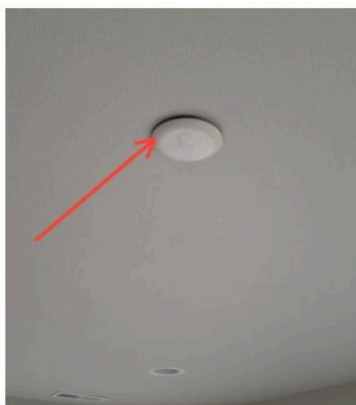
Electrical box cover in living room is not correctly seated. Might indicate mis-installed box beneath it.

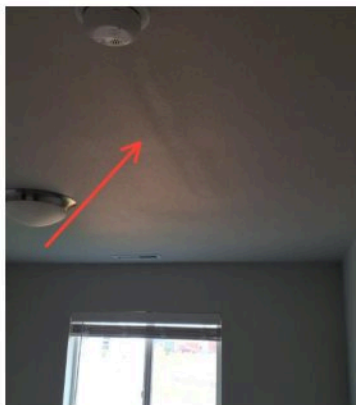
Cosmetic finish on ceiling

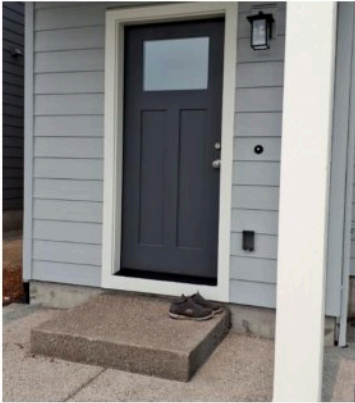
cosmetic on front door

Minor cosmetic issue

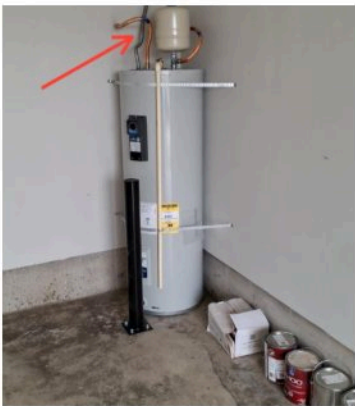
No water shutoff at water heater

A water shutoff valve on the intake (cold water) side of the heater is very helpful in the event of a water heater failure, leak, or maintenance.

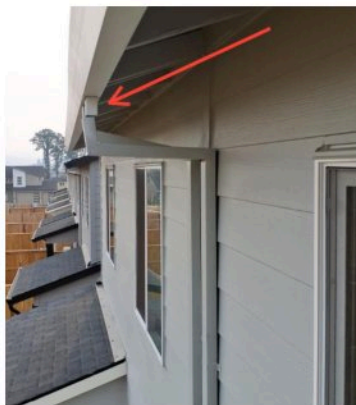
Downspout has separated from gutter, which will allow excessive rainwater to be in contact with (and eventually damage) siding. It will also collect at the corner of the foundation and may cause moisture problems under the home, or unusual/uneven ground settling leading to foundation/structural damage.

Downspout Separation

Recommendation: Have a contractor reconnect the downspout.

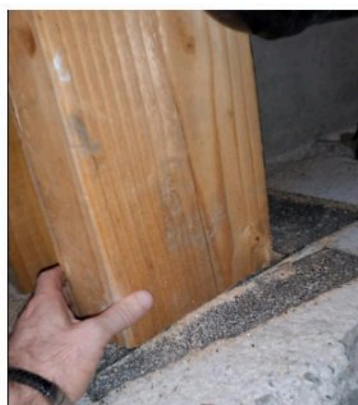
Moisture was observed in the crawlspace although there was not any recent rain. The cause is unknown. Crawlspace should be monitored for moisture intrusion. Additional drainage may be needed around foundation perimeter if it persists, as moisture in the crawlspace can contribute to rot, mold, and damage to the insulation, flooring, and crit-

ical home structures.  
Recommendation: Continued monitoring.

Moisture observed
